## LESSONS LEARNED FROM CATASTROPHIC CABIN CREEK CONFINED SPACE INCIDENT

JEROME E. SPEAR, CSP, CIH, FAIHA

### Understanding the Fatalities at Cabin Creek Hydroelectric Plant

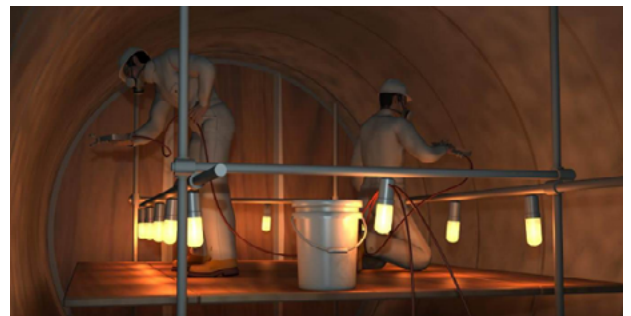
*In one of the worst confined space catastrophes in the U.S., 5 workers were trapped while coating the inside of an enclosed penstock, as shown in this fictional representation.*

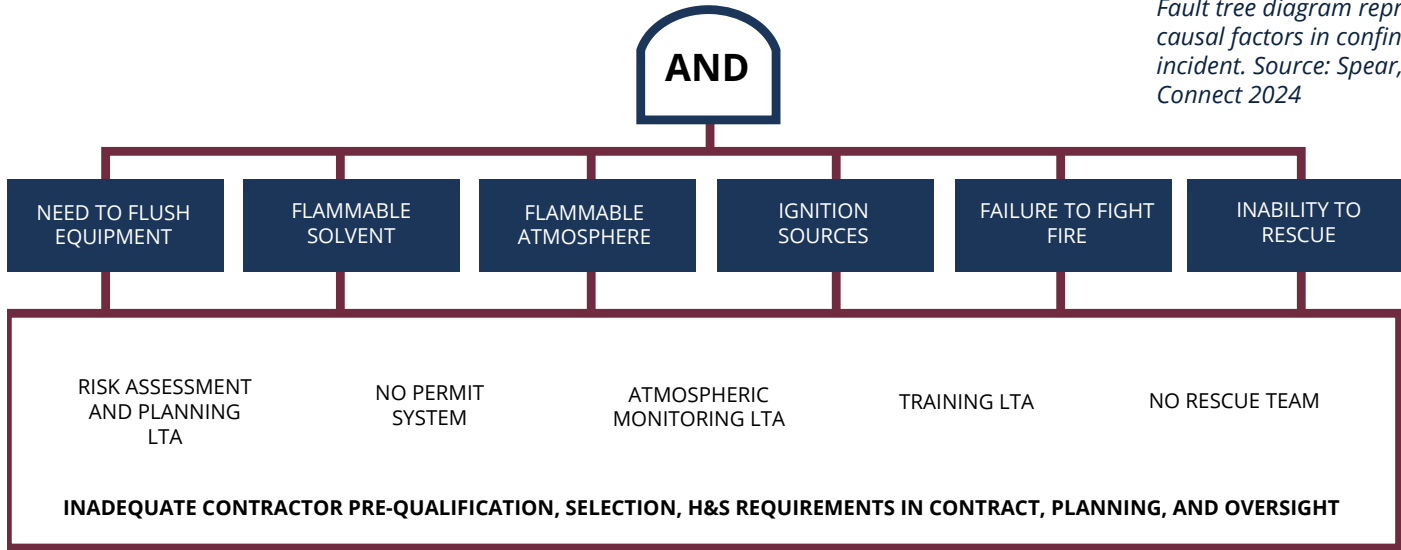
# 5-Worker Fatal Fire in Confined Space

*Fault tree diagram representing causal factors in confined space incident. Source: Spear, AIHA Connect 2024*

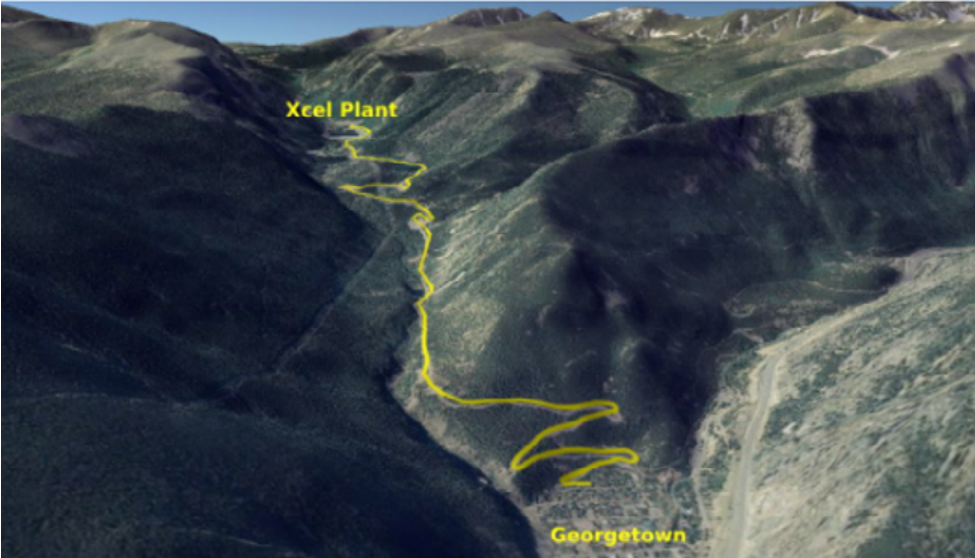
Attempts to rescue the workers were complicated by a lack of exit points. Only one exit was available to workers, far away from the application location. The emergency response plan for rescue services was to call 9-1-1. However, no emergency responders with confined space technical rescue certification were at the plant nor immediately available. The closest certified community rescue services were located 1 hour and 15 minutes away.

Emergency responders were located more than an hour away from the plant at the time of the incident. Source: CSB.gov
